# **Development of lightweight structures in BESST**

Sven-Erik Hellbratt (Senior Specialist Composite Structures) ThyssenKrupp Marine Systems AB

# **Development of Steel-Composite solutions**

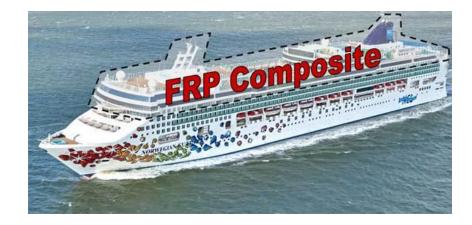
#### **Application case No 1**

"Deck structure above of Deck 11 of Norwegian GEM". (MW)

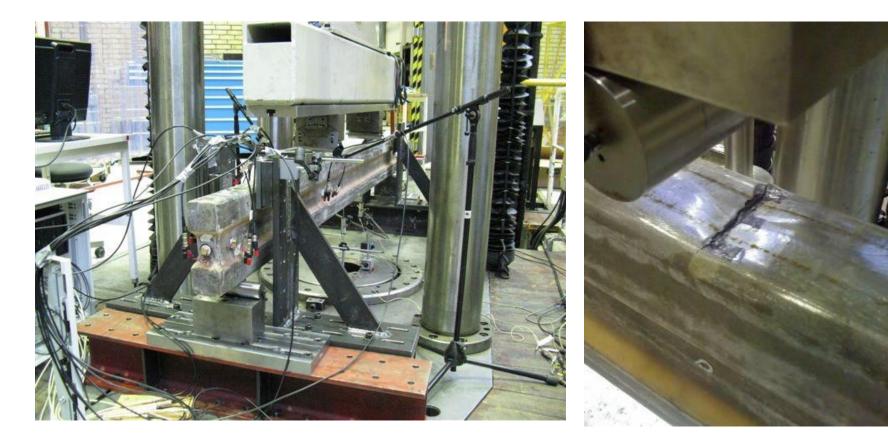
# Fatigue testing of the steel/composite joint

# Fatigue failure in the steel after 1.8 million load cycles at 100kN No damages in the steel/composite interface

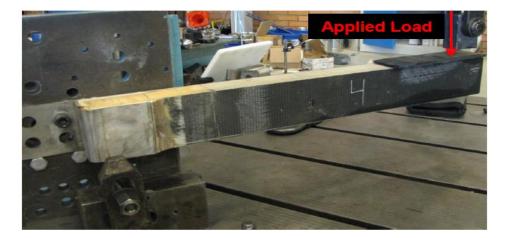
# Ageing tests in high humidity

Conditioned samples are placed on a net in a box with circulating water underneath the net. A lid is placed on top to increase humidity

- 160 kN hydraulic press
- Force and displacement from press continuously recorded 5 times/second
- Load applied at 1100/885 mm distance from support (885 mm for Syl3 specimens)
- Load is applied at a rate of 10 mm/minute
- Load is applied as a pushing force onto the edge of the sample
- Conditioning at high humidity, 50°C for 120 hours, circulating water

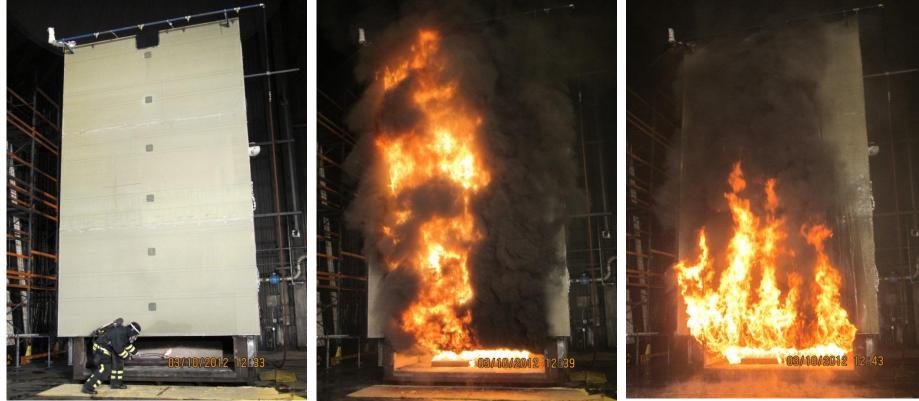
# Fire tests, outside fire, Application case No 1

#### **Drencher and external flame spread test**

Ignition

Activation(~5 min)

Controlled (~7 min)

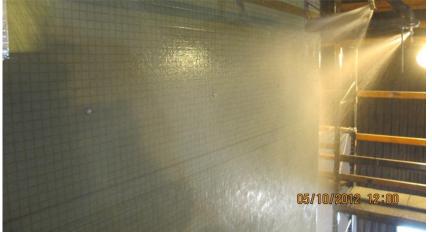
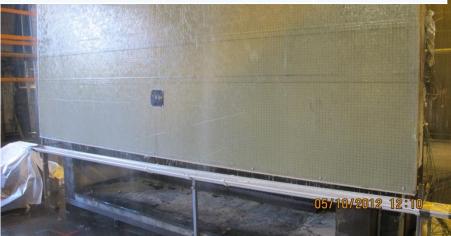
#### Fire tests, outside fire, Application case No 1

Water application system

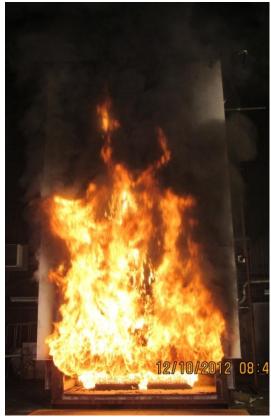
## Fire tests, outside fire, new treatment of fibre and resin systems

#### LEO – No drencher activation

Fully developed

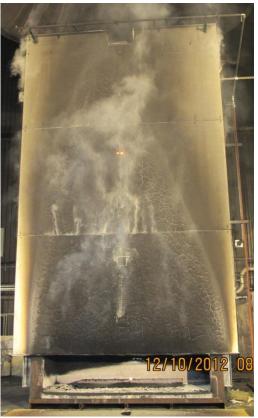
Self-extinguished

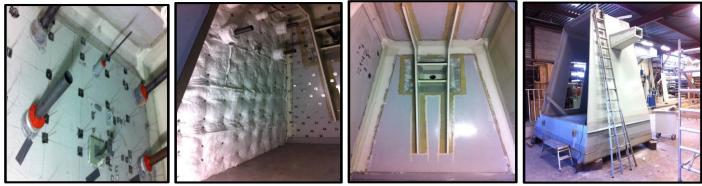
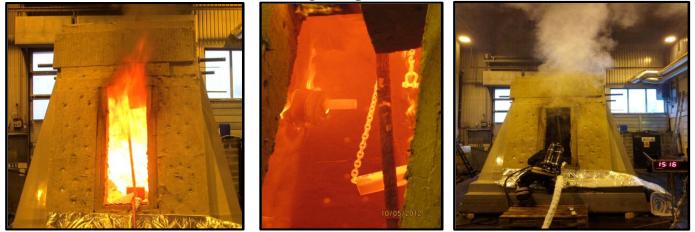
# Fire test Application case No 3

Several ideas and solution for outfitting and penetrations were realised and tested.

#### Successful fire test on developed solutions

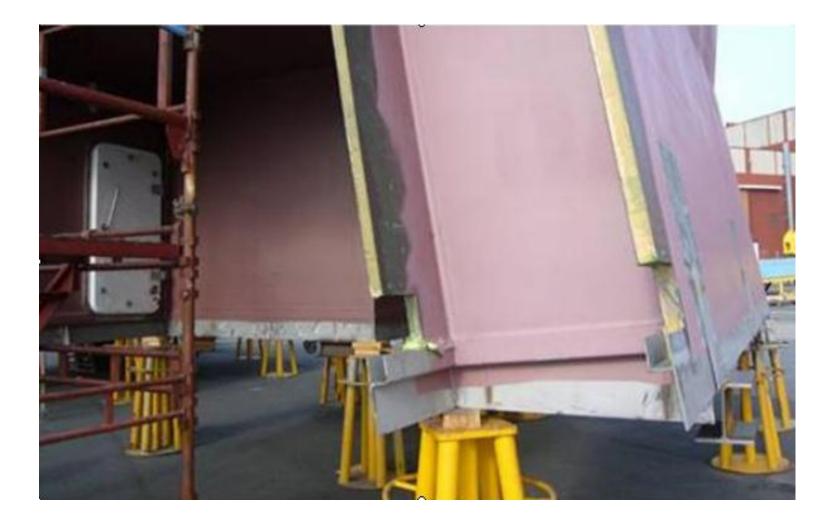
#### Steel / composite joint that can be used in traditional steel shipyards conditions in full scale production
