# Engineering analysis report - Norwegian Future

Franz Evegren

This report contains the engineering analysis in accordance with SOLAS chapter II-2 regulation 17 for the panamax cruise vessel the Norwegian Future. The five upper decks were redesigned in FRP composite. A prerequisite was that thermal insulation was provided to all interior surfaces in order to achieve 60 minutes of fire protection. Fire development on open deck and fire spread through openings and vertically along the outboard sides of the ship were identified as fire scenarios where differences in fire safety would be significant. A number of deviations to prescriptive requirements were identified. The deviations particularly concern the fact that FRP composite is combustible. This although has effects on a number of prescriptive requirements, functional requirements and also on implicit requirements in SOLAS. In the quantitative assessment a number of identified potential fire hazards were managed independently whilst others were incorporated in fire scenarios involving representative space groups. Different combinations of risk control measures, forming 21 trial alternative designs, were quantified. In conclusio

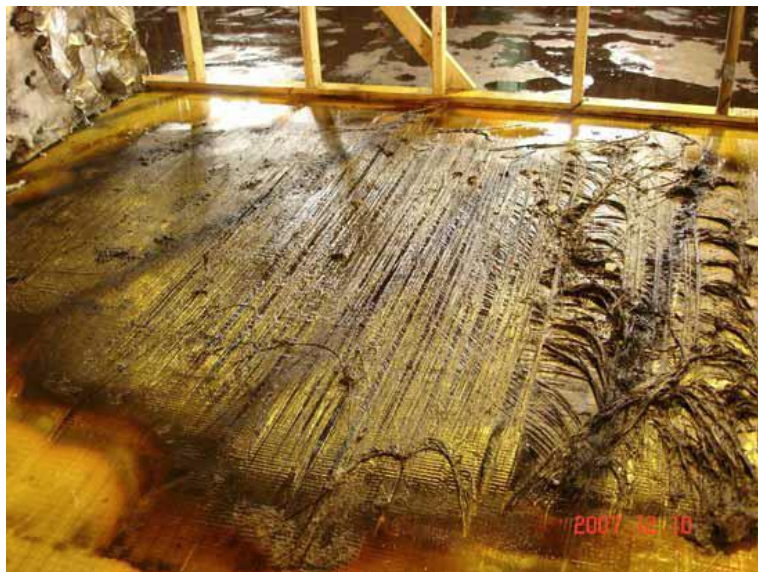
Figure 4.6. Damages to the FRP composite deck as a result of the uncontrolled fire, after the floor construction had been removed.

After the removal of the aluminium floor plates and the underlying insulation, it could be concluded that the composite deck was blackened and burnt in a rectangular pattern that was approximately 2700 mm in length and 2100 mm wide (5.7 m<sup>2</sup>). This is shown in Figure 4.6. The core was damaged in a pattern that was 1500 mm in length and 1300 mm in width (2 m<sup>2</sup>).

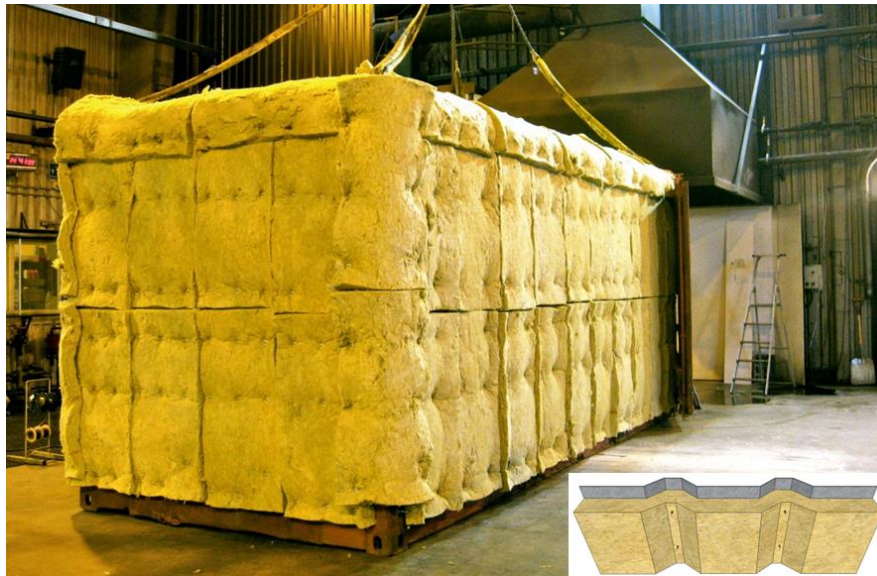
Figure 4.8. The insulated steel container, ready to be used in the experiments.

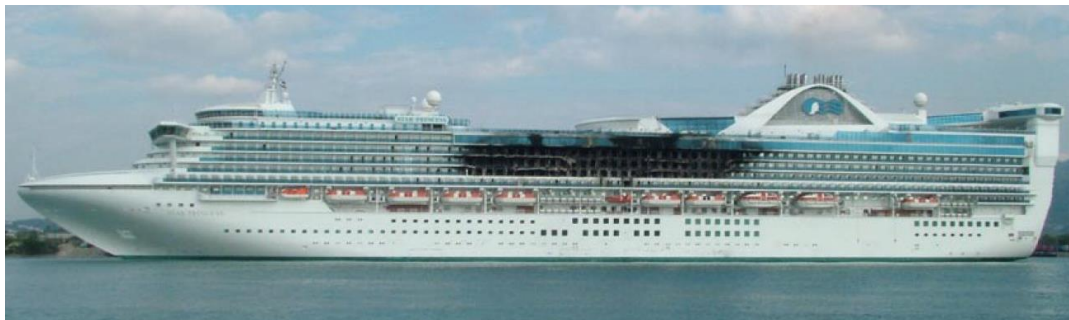
However, the fire on Star Princess [25] indeed showed that the probability of outboard fire spread exists also on prescriptive ships. The damage on the ship's port side is illustrated in Figure 4.14. The presence of combustible materials on balconies on the outside of the hull is a potential fire hazard which can fuel a fire sufficiently to produce enough heat to break the glass door and spread to the adjacent cabin. This is how the fire developed on the Star Princess [25]. Since then new requirements have been adopted which restrict the amount of combustible materials on the balconies unless a sprinkler is provided specifically for the balcony. The combustible materials on the balconies of the reference ship, illustrated in Figure 4.13, are supposed to be rather restricted as the ship lacks balcony sprinkler.

Figure 4.14. Extent of damage on port side of the Star Princess after outboard fire spread [25].

aluminium structures melted and collapsed. A total of 79 cabins were condemned by the fire and another 218 were damaged by fire, smoke or water, as shown in Figure 4.14 [25]. These are considered to be representable consequences from an unhindered fire on a prescriptive ship corresponding to the time frame on the base design. The number of passengers exposed to critical conditions on the Star Princess were 14. In the prescriptive design 9 persons have above already been assumed exposed to untenable conditions in the early events of the fire scenario. Considering that fire-fighting efforts in the prescriptive design have been ineffective, the fire would be unhindered to a larger extent. It was therefore assumed that the representative number of casualties such a fire scenario in a prescriptive design would be another 10 persons.

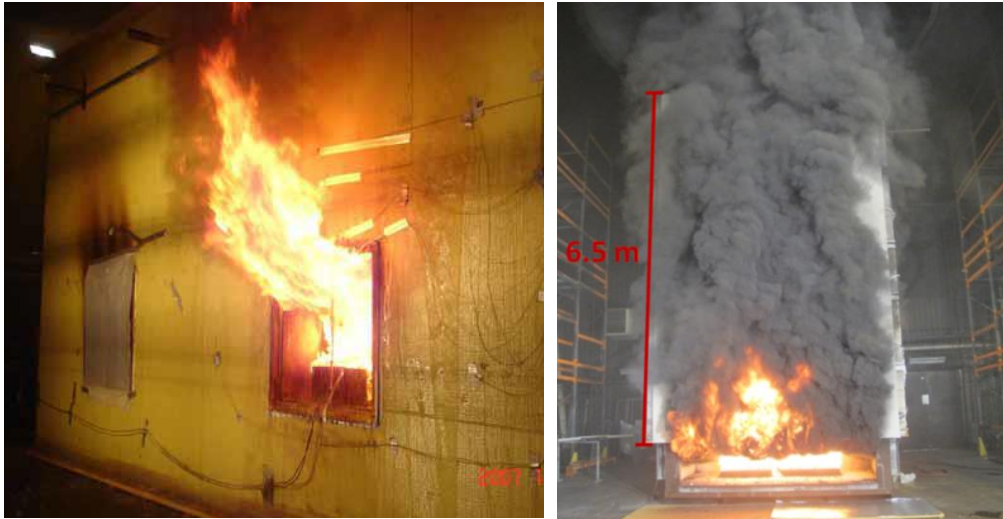
The FRP composite areas of limited height but significant width will nevertheless affect the potential for fire development on outboard surfaces. When trying to appreciate how much the added combustible exterior vertical surfaces will affect the potential for fire growth it is useful to refer to the tests carried out on fire spread from a cabin window and balcony opening. Representative fire exposures when a fully developed cabin fire spreads through a window and a balcony opening are illustrated in Figure 4.17. No addition is given from combustible surfaces in these cases.

Figure 4.17. Representative fire exposure to outboard surfaces when a cabin fire spreads through a window [16] or a balcony opening [26] (exterior surfaces are non-combustible).

It was shown in the tests that fire spread is fast in the vertical direction and that lateral fire spread is rather slow (in idealized conditions). Furthermore, looking at Figure 4.17 one can argue that the addition of 1 m of combustible material above the opening will not make such a big difference. The fire exposure to a window, balcony or other structure further up the ship side will be significant regardless of the addition of 0.5-1 m of FRP composite. However, it is necessary to recognize less idealized conditions, particularly the fact that it is usually windy at sea. When there is a fire on the outboard side of a ship, fire development may be either assisted or hindered by the weather. On the *Star Princess*, a strong wind hastened fire spread, until the captain altered the ship's course to minimize winds on the port side where the fire had broken out (this is an advisable approach, as concluded in the evaluation of fire-fighting routines, as well as to attack the fire from the upwind side if possible [18]). Accounting for the effect on fire spread from the wind makes it clear that the combustible surfaces must be accounted for also in the lateral direction. A fire scenario where large areas of FRP composite could be involved is then not hard to imagine. For example if a cabin fire spreads through a balcony in the forward part of deck 10. As illustrated in Figure 4.18, in case of a wind from the front/port side it is not hard to imagine a fire scenario with involvement of large areas of FRP composite. This would mainly be due to the fact that the surfaces are combustible.

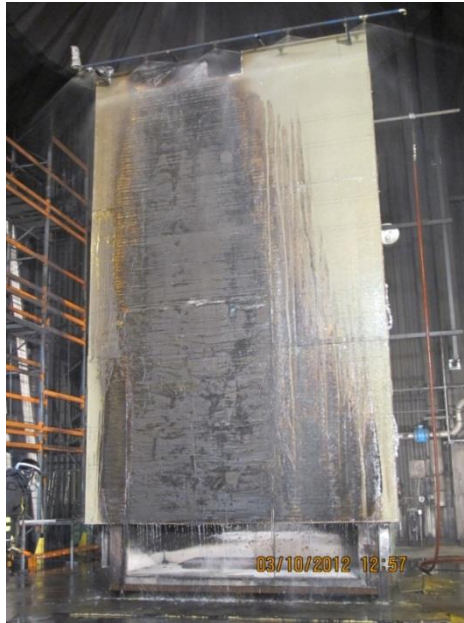
Figure 4.24. Fire damage on a FRP composite panel after a two minute fire exposure, representing a cabin fire through a balcony opening (structural integrity was lost throughout the whole height of the 6.5 m panel).

Based on [26], an unhindered large fire on outboard sides in the base design is assumed to spread quickly in the vertical direction and also in the lateral direction, depending on the influence of wind. The fire could in other words result in direct consequences for evacuating and hesitating passengers. The people in the superstructure will need to be evacuated instantly and in a worst-case scenario many of the passengers in the effect zone will be exposed to smoke. Furthermore, the tests showed that after the FRP composite panel ignited a few minutes into the fire exposure, it only took about 2 minutes until structural integrity was lost in large areas, which was assessed from the area where delamination had occurred between the core and the surface laminate. This area formed a triangle with almost the same width as the opening and a height higher than the 6.5 meter panel, probably about 8-9 meters, which may be distinguished in Figure 4.24. Even if the loss of structural integrity would be local in the early stages it could thus affect a large vertical area over several decks.

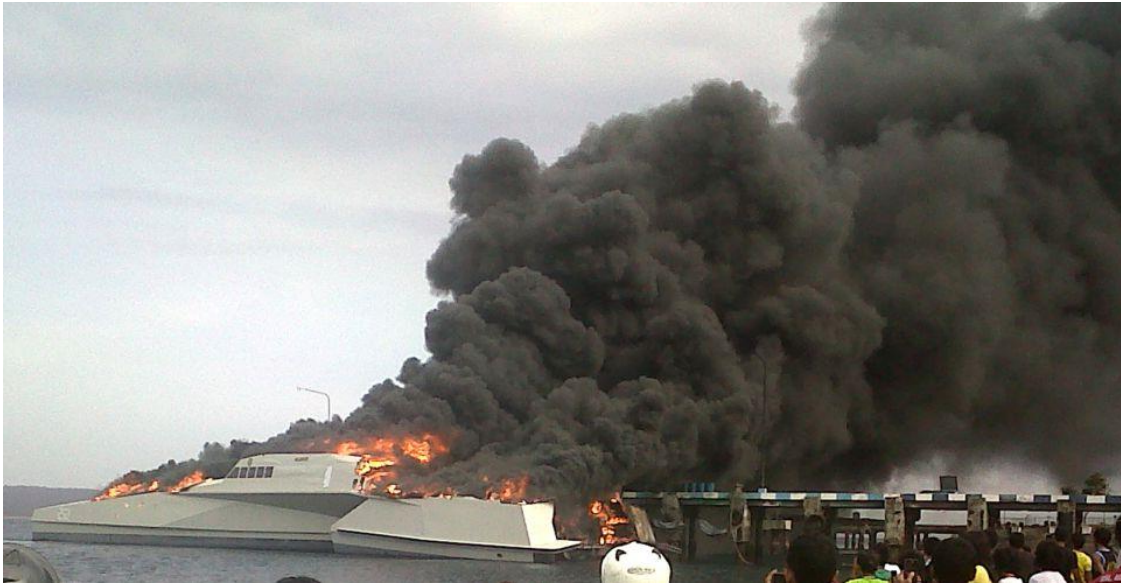
Figure 4.25. The Indonesian navy ship Kri Klewang had unprotected FRP composite surfaces on exteriors where a large fire established.

Later on, a worst-case scenario could involve large parts of the superstructure. This could give a fire on the upper deck similar to the fire on the Indonesian navy ship Kri Klewang, built in unprotected FRP composite. This could not only cause inhabitable conditions due to collapse. It could also cause an earlier decision to disembark and hinder disembarkation since structural parts of the ship may block usage of the life boats underneath, as further elaborated subsequently.

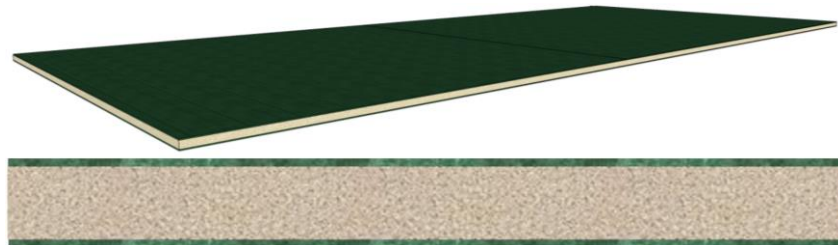
Figure C1. Illustration of an FRP composite panel (top) and a close-up on the lightweight core and the rigid and strong fibre reinforced laminates (bottom).

An FRP composite panel essentially consists of a lightweight core separating two stiff and strong FRP laminates, which is illustrated in figure C1. The core material generally consists of PVC (polyvinyl chloride) foam or balsa wood and the face sheets are generally made by carbon or glass fibre reinforced polymer. When these laminates are bonded on the core the composition altogether makes up a lightweight construction material with very strong and rigid qualities [9].

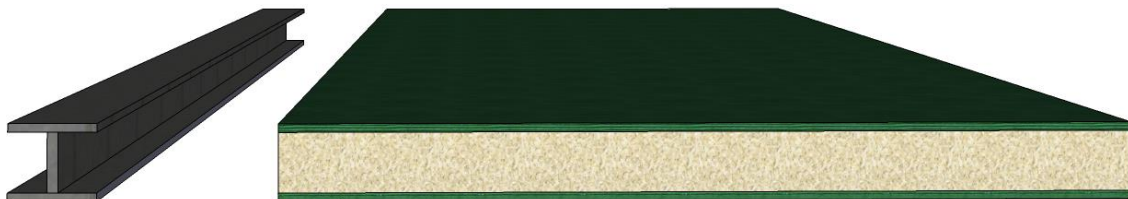
Figure C2. Illustration of how the lightweight core works as a prolate stiffener in order to provide the FRP composite panel with a distribution of loads similar to an “I-beam”.

The key to the prominent properties of the FRP composite is anchored in the separation of the strong laminates. It makes them effective in carrying all in-plane loads and gives ability to withstand high working strains. The separation also provides bending stiffness when exposed to local transverse loading. The core, separating the face sheets, works as a prolate stiffener in the whole structure. It carries local transverse loads as shear stresses, comparable with how webs of stiffeners behave in stiffened steel panels. The way the material is designed makes it altogether function as a stretched out “I-beam” (see figure C2) and leads to an advantageous distribution of stresses [45, 46].
