**E-LASS Conference**  
**October 10<sup>th</sup>-11<sup>th</sup>, 2017, Pula**

**DESIGN OF CAR DECKS WITH  
COMPOSITE PANELS INTRODUCED  
ON A 7000 CARS CAR CARRIER**

Vito Radolović (ULJANIK)  
Michael Rahm (RISE)

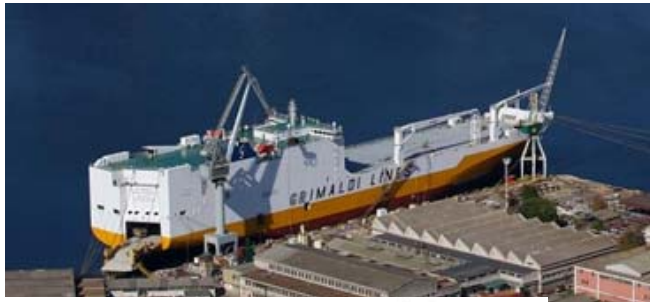
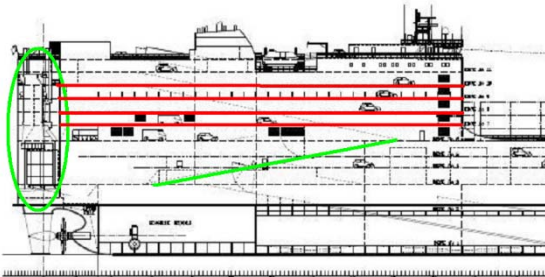
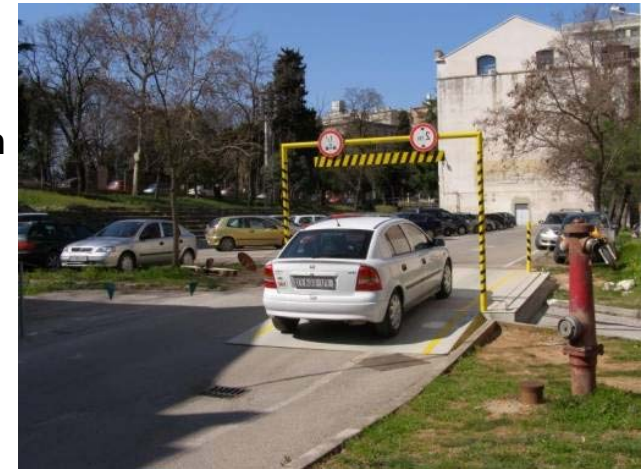
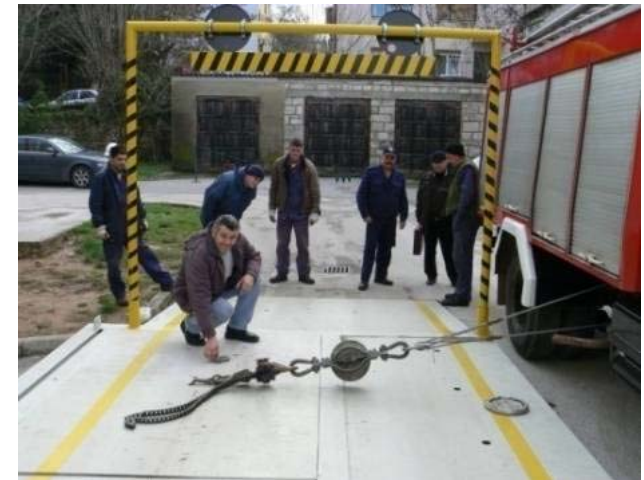
## DESIGN OPTIMISATION , PROTOTYPE AND TESTING

**DELIGHT TRANSPORT - Cargo deck of composite materials for RO-RO vessels**  
(FP6-031483, 2006-2010)

- Deck structure weight reduction up to 35%
- Fuel consumption reduction up to 2% → CO<sub>2</sub> emission reduction
- Total Lifecycle operation cost savings
- Production process cost reduction
- Satisfactory test results

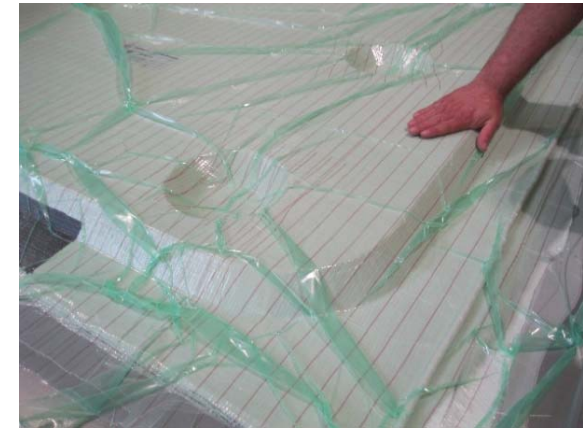
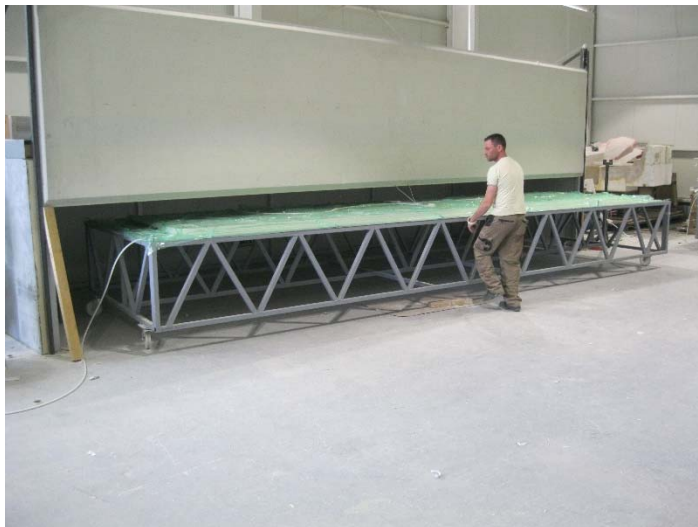
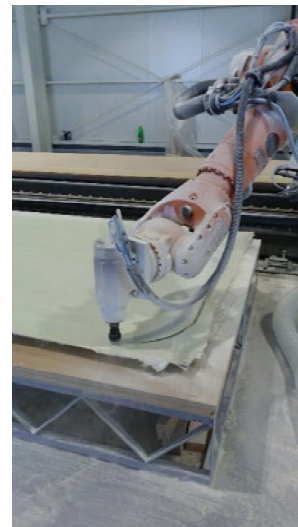
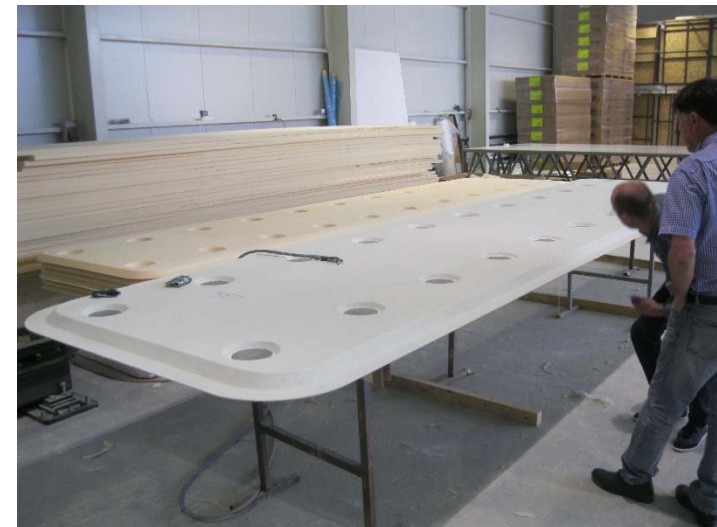
## IMPLEMENTATION ON CAR CARRIER / 7000 cars

1043 composite panels installed on three upper decks (glass fibers, PVC Core, vacuum infusion,...)

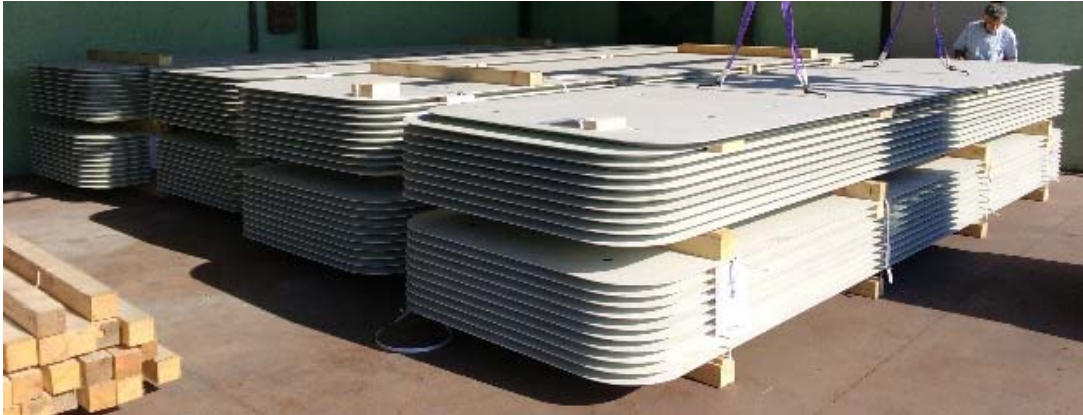
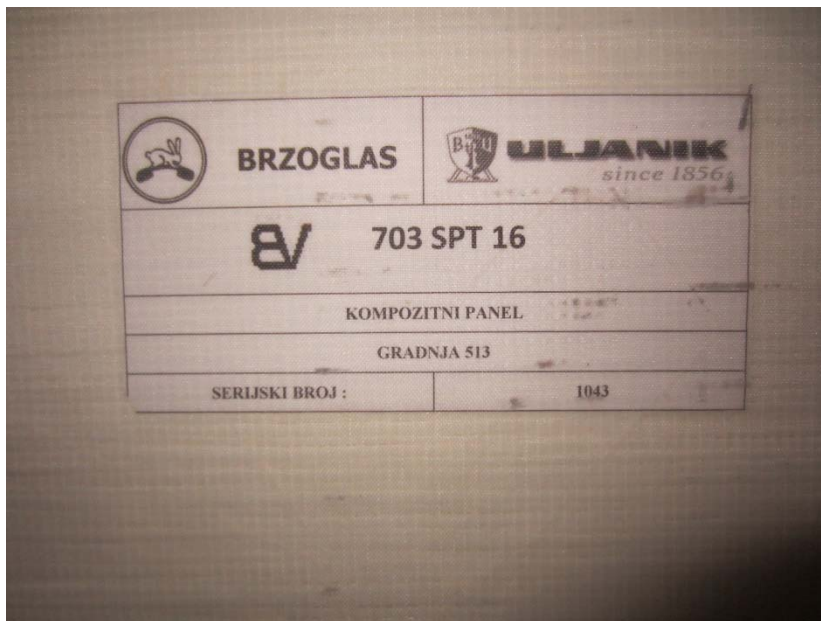
**FIBER CONTENT M=74.2 %**  
200 tests (1000 specimens)

**PANEL WEIGHT =155 kg**  
**TOTAL 162 t** (1043 pcs)

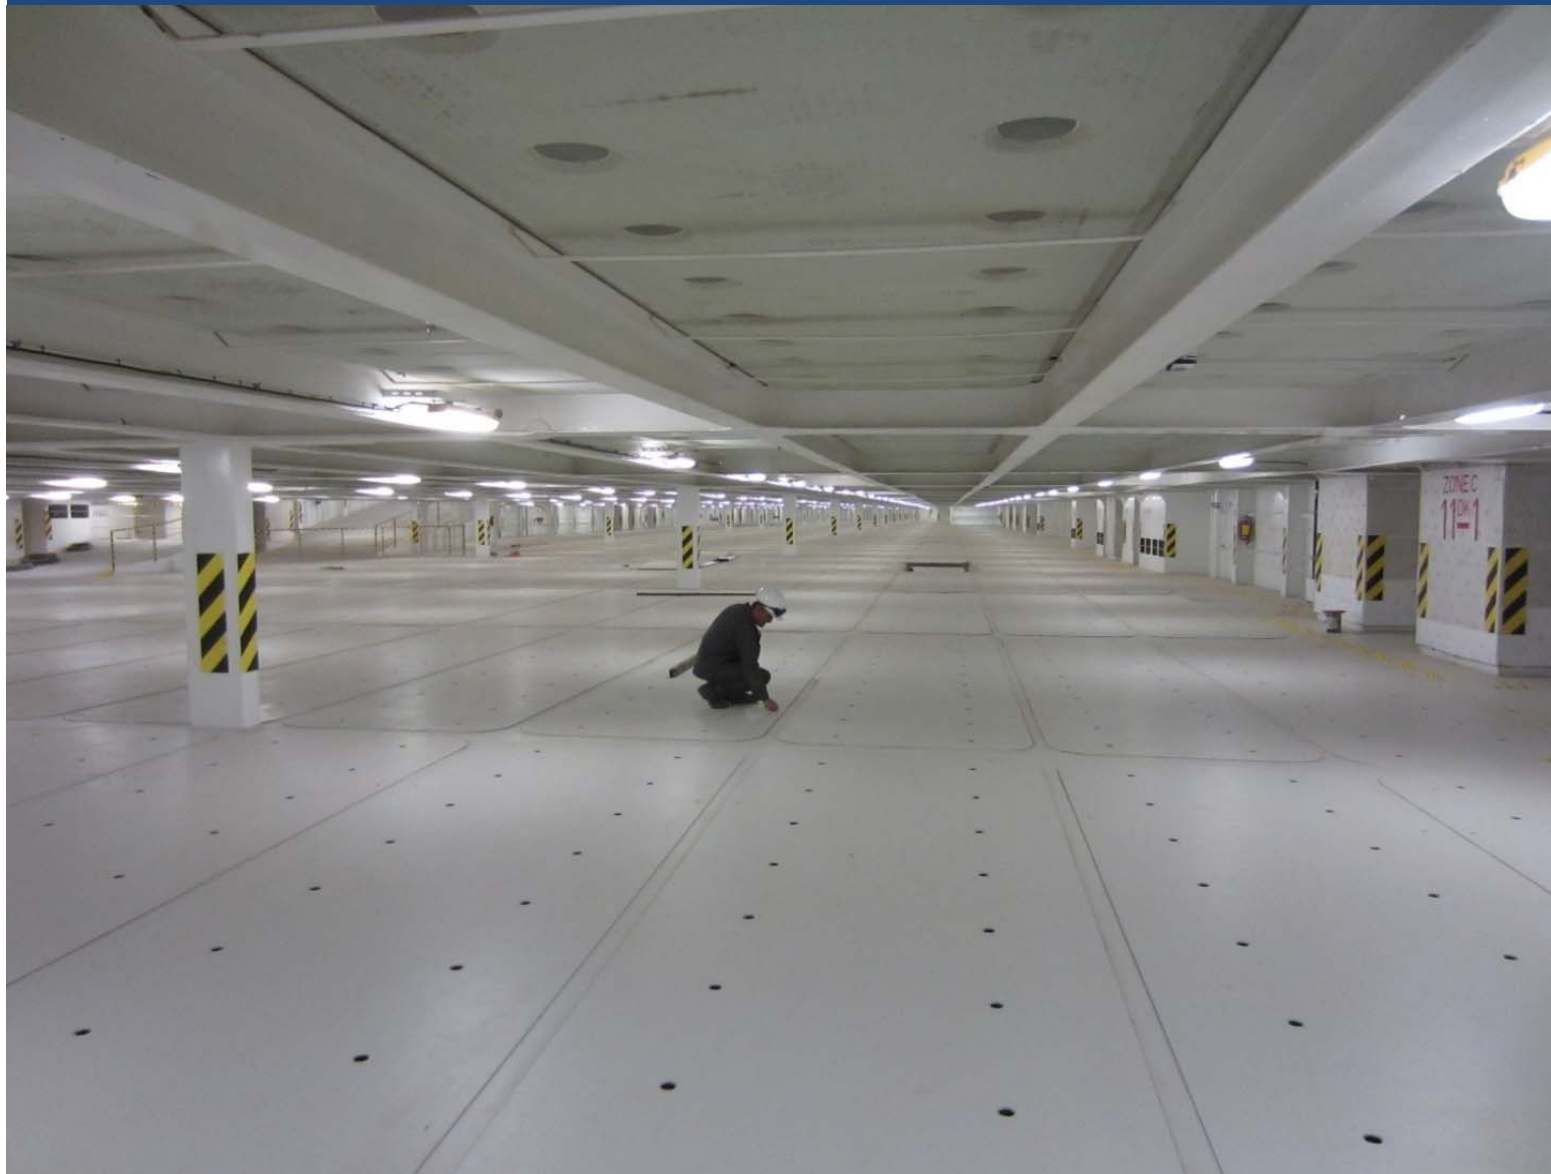
Flexible bolt  
connection

Total building  
tolerance at  
each connection

**+5 mm**

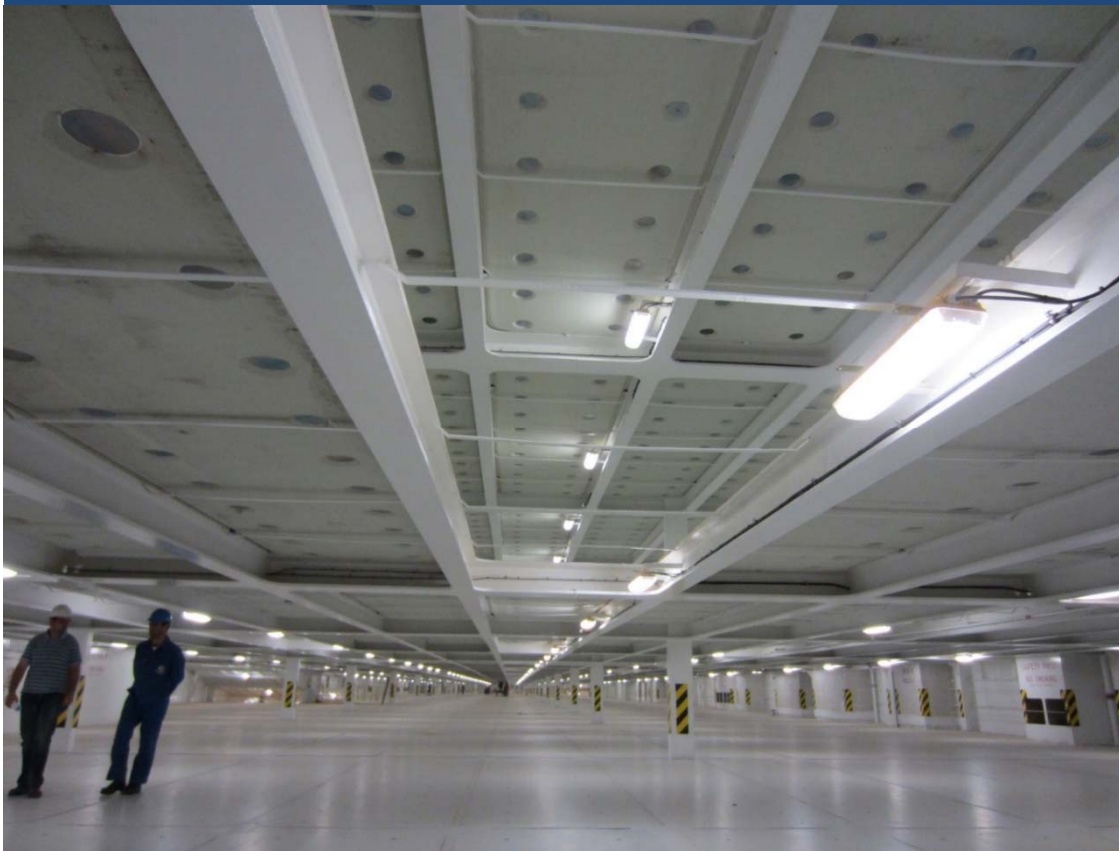
- Total area covered by composite structure: **12600 m<sup>2</sup>**  
→ 2.5 football field
- Total Weight reduction of **230 t**
- Steel weight reduction of **390 t**  
→ equal to the weight of one conventional steel deck
- Improved stability performance  
→ Reduced ballast weight in double bottom tanks  
2.5x weight reduction or **575 t**

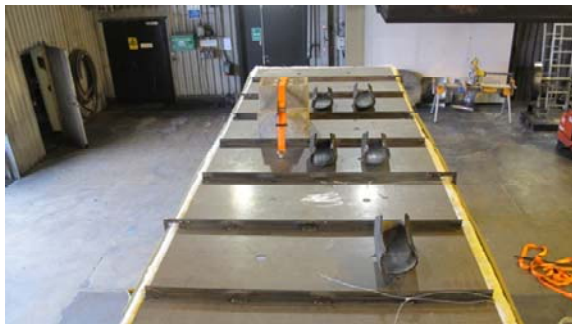
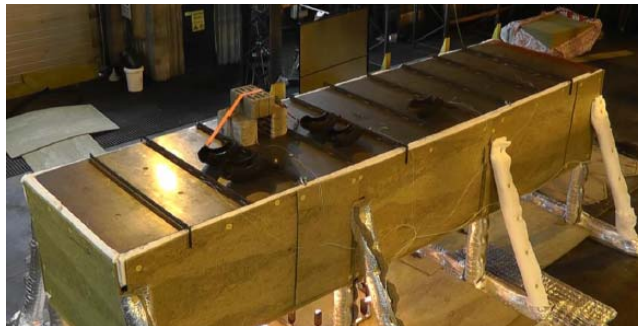
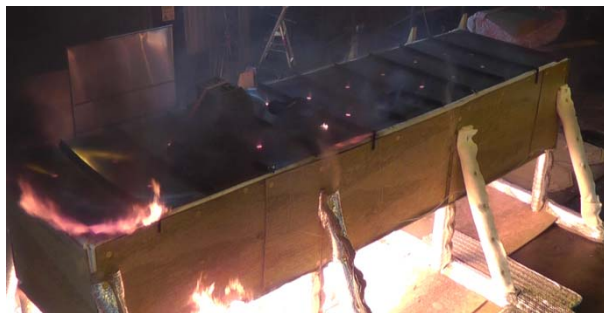
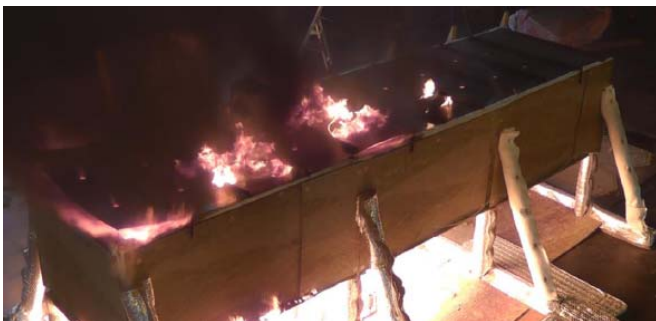
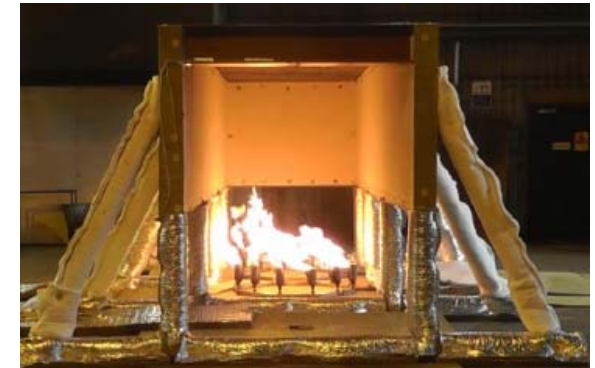
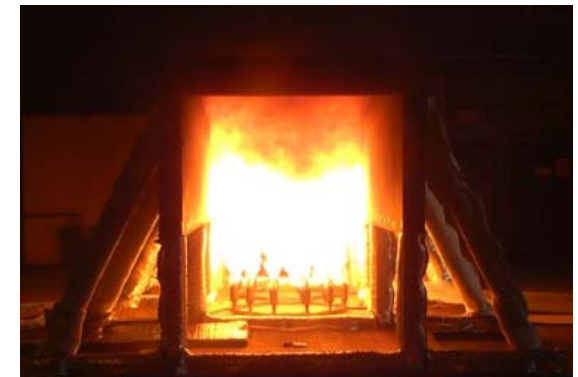
## Steel deck:

- Fire growth rate
- Vertical fire spread

Observation	Time for observation		
	Test 1, Steel	Test 2, FRP FR-coated	Test 3, FRP
Smoke from the tyres on the deck	04:54	03:54	03:26
Flames through lashing holes	08:45	04:12	05:30
Ignition of first tyre	09:41	05:22	06:06
All tyres are burning	10:21	06:26	06:09
Lashing ropes ignites	10:51	Not established	N.A.

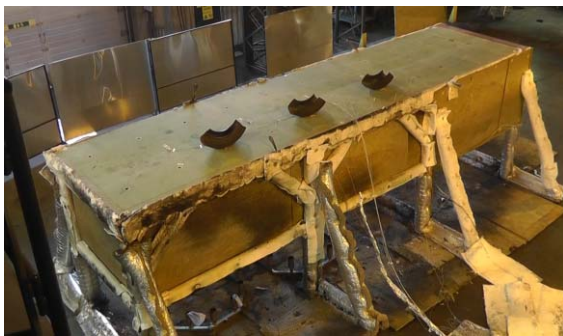
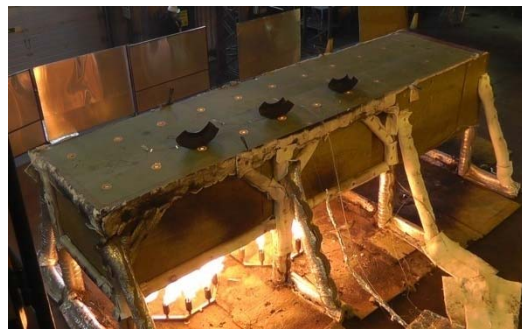
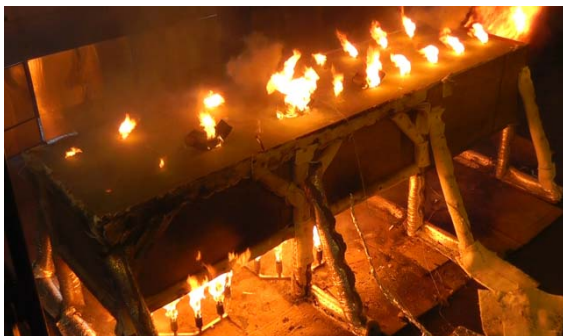
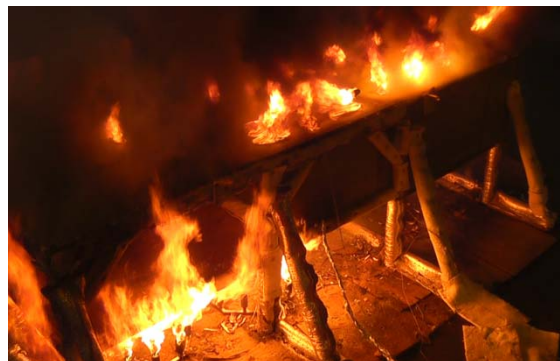
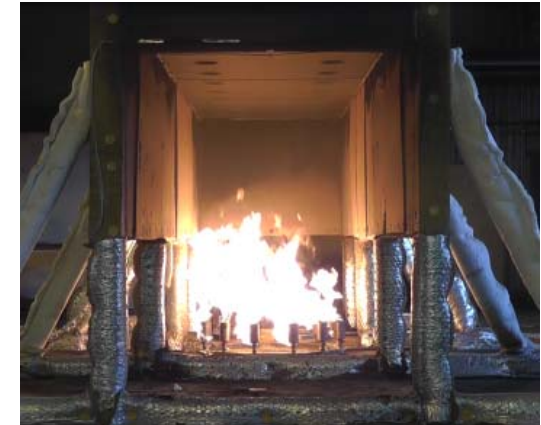
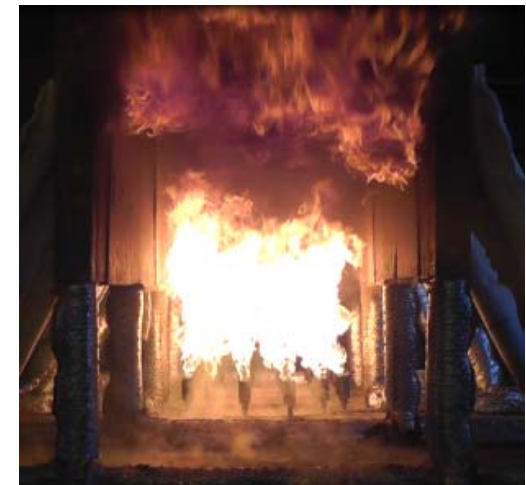
## FRP deck:

- Fire growth rate
- Vertical fire spread

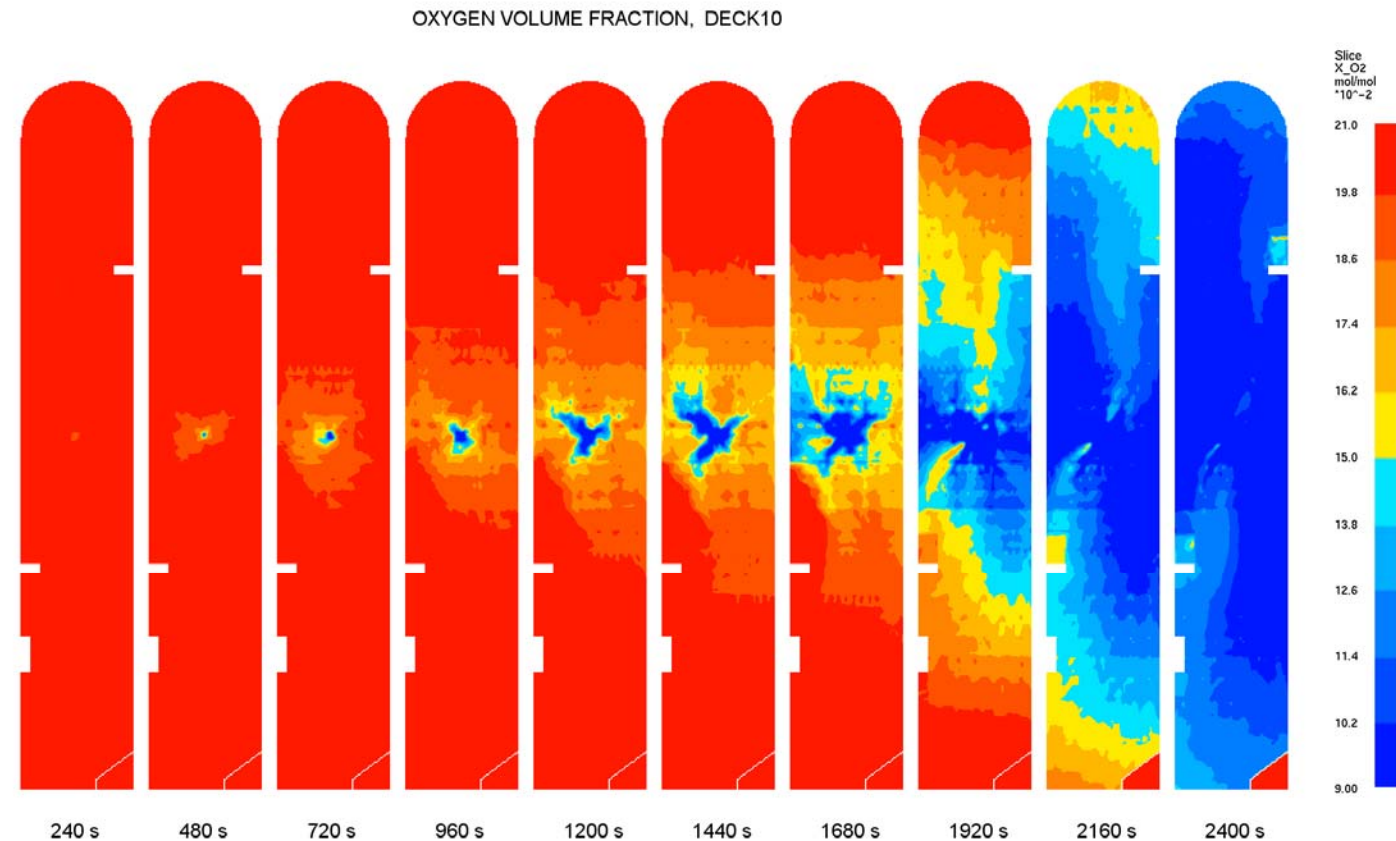
- Steel design
- Land scenario
- Fire start on deck 10

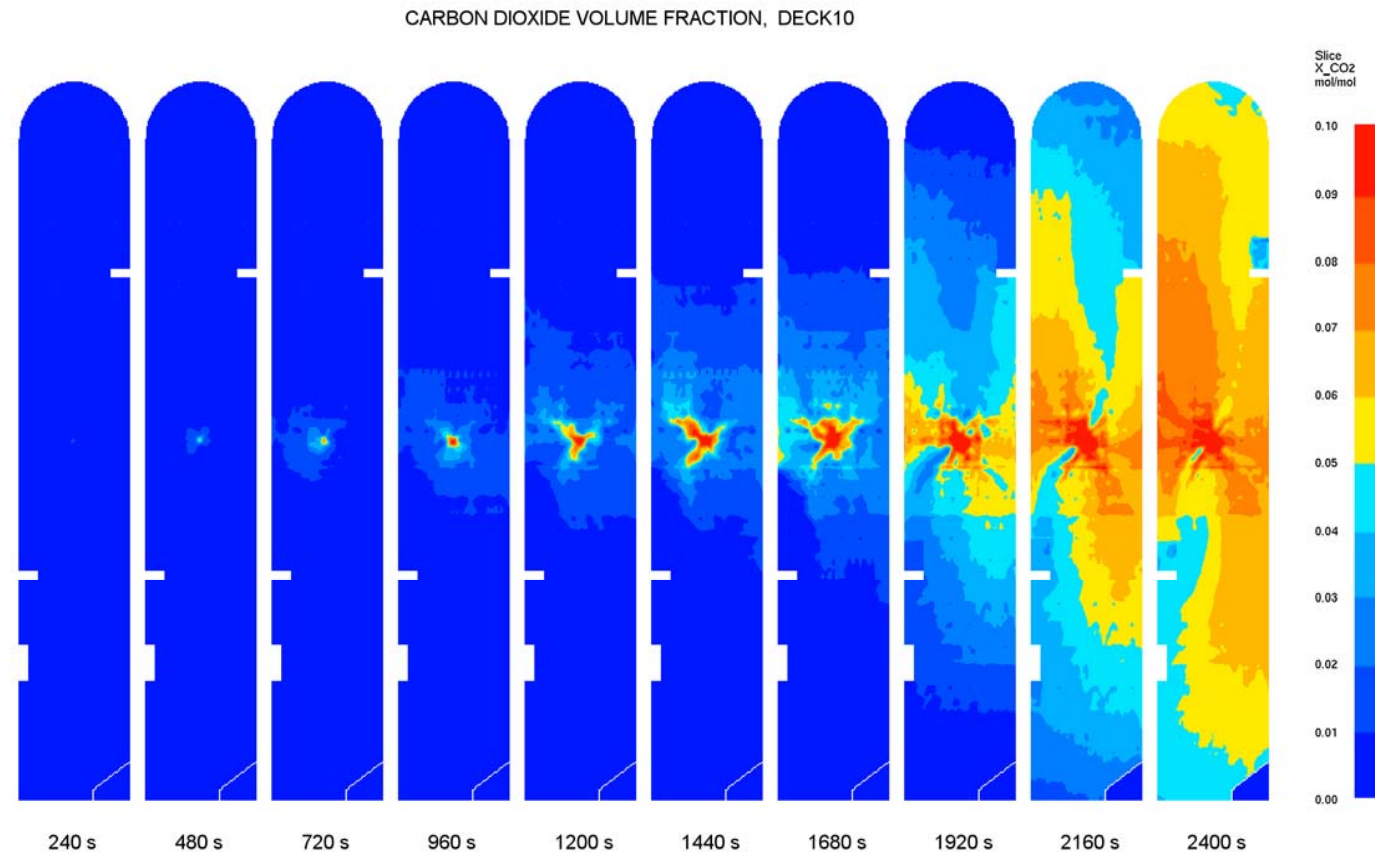
- Steel design
- Land scenario
- Fire start on deck 10

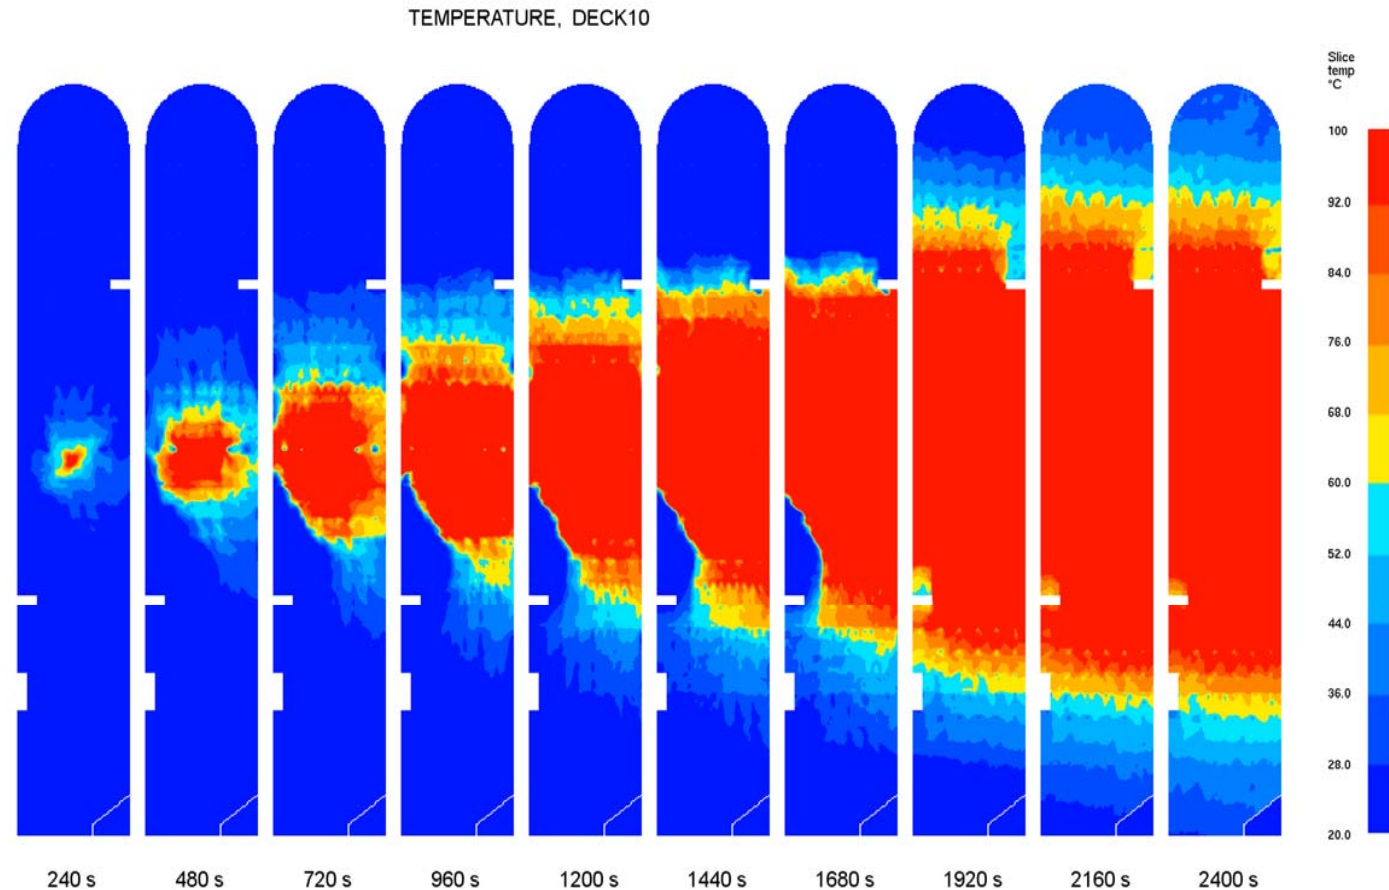
- Steel design
- Land scenario
- Fire start on deck 10

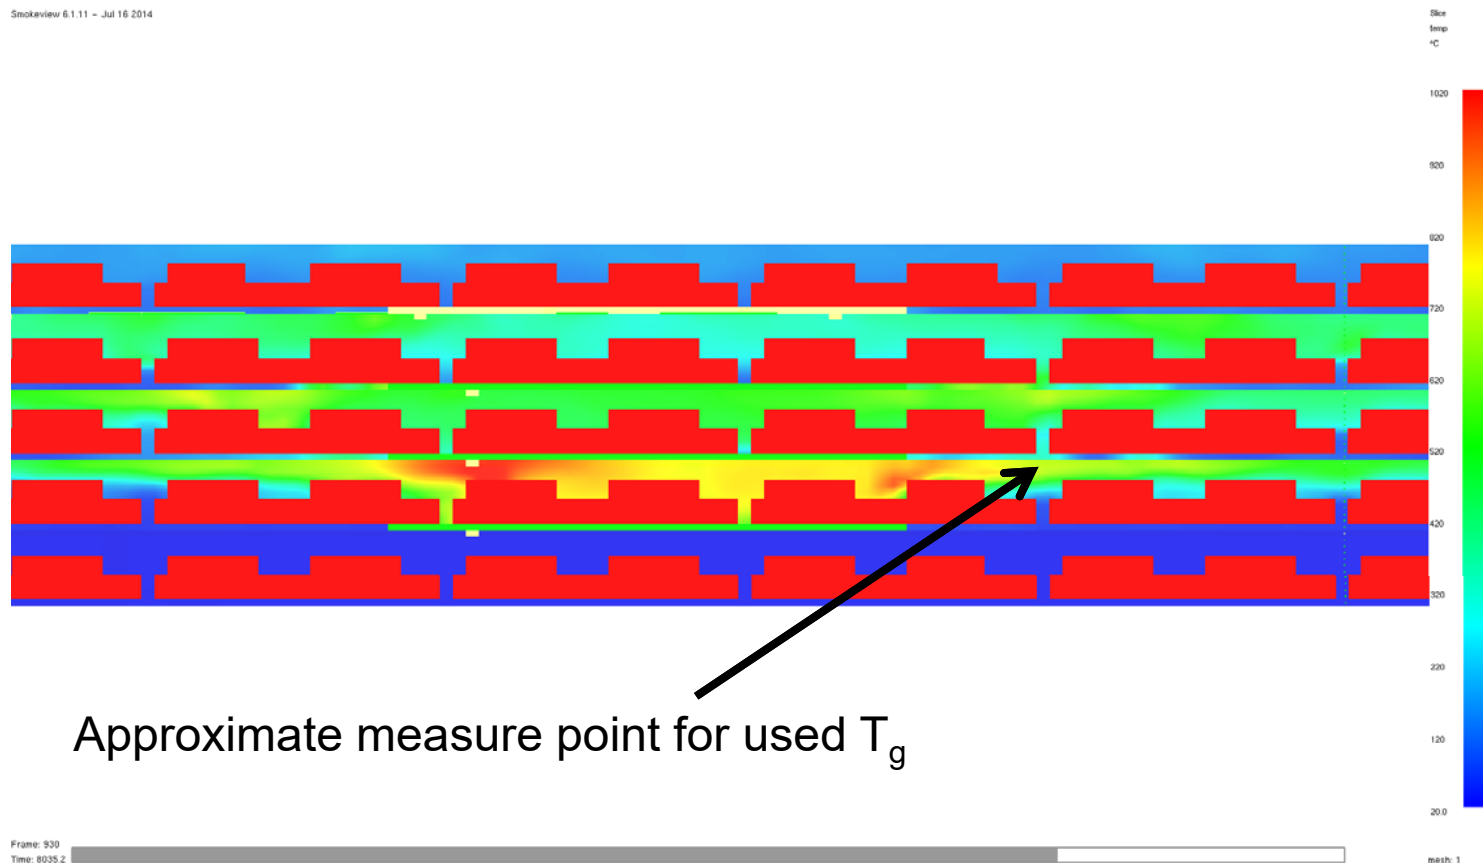
## Steel beam temperatures

- Gas temperatures taken from CFD simulations 40 cm above and below the deck closest to the fire.
- Homogene steel temperature.

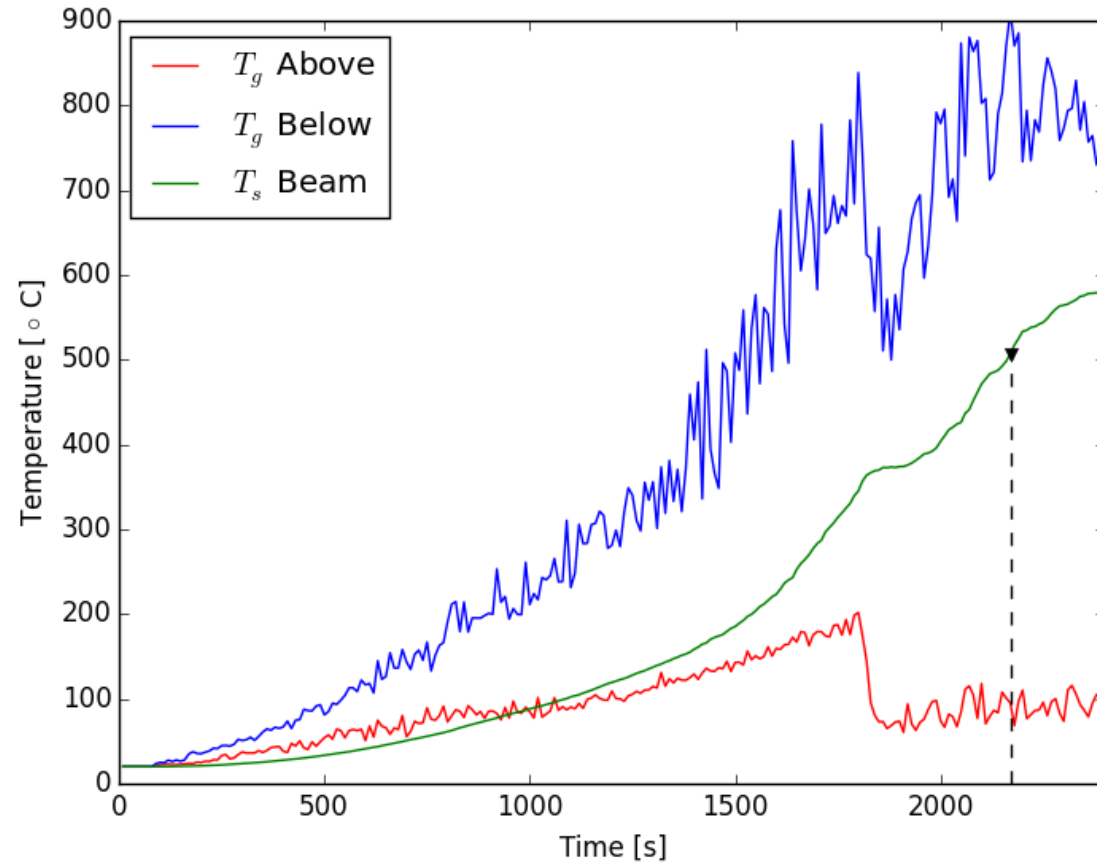
## Steel beam temperatures

- Steel design
- Land scenario
- Fire start on deck 10

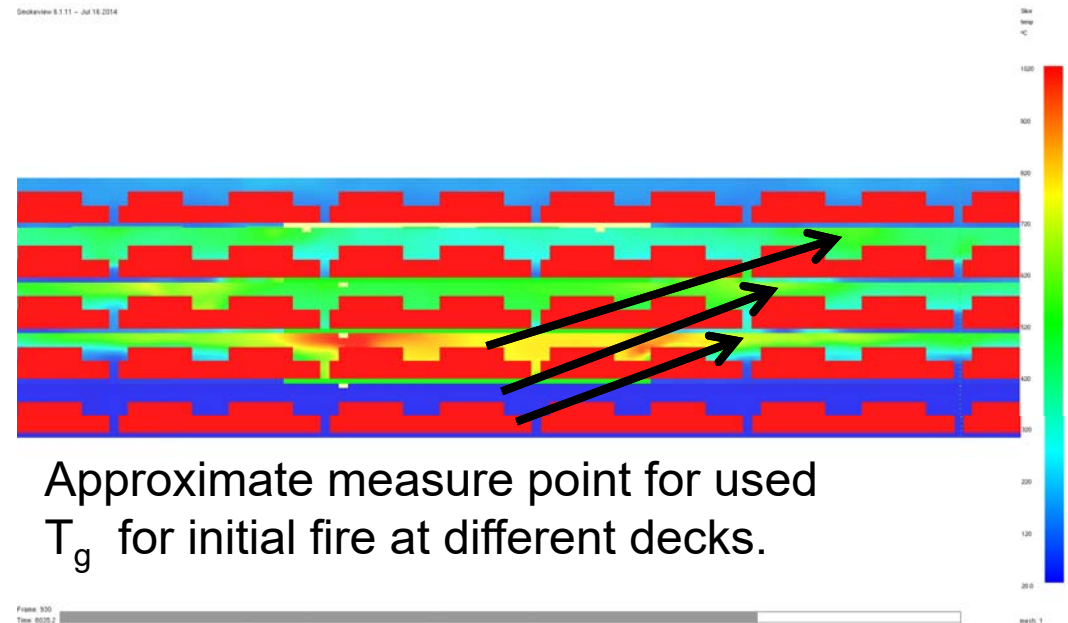
## Fire spread to accomodation

- Gas temperatures taken from CFD simulations 40 cm below the deck right above, 2 decks above, and 3 decks above the initial fire.
- Fire spread is assumed to happen when  $\Delta T = 140^{\circ}\text{C}$  which means  $T=160^{\circ}\text{C}$ .
- Material properties for worst possible A30 deck used.
- No cooling on top of deck.

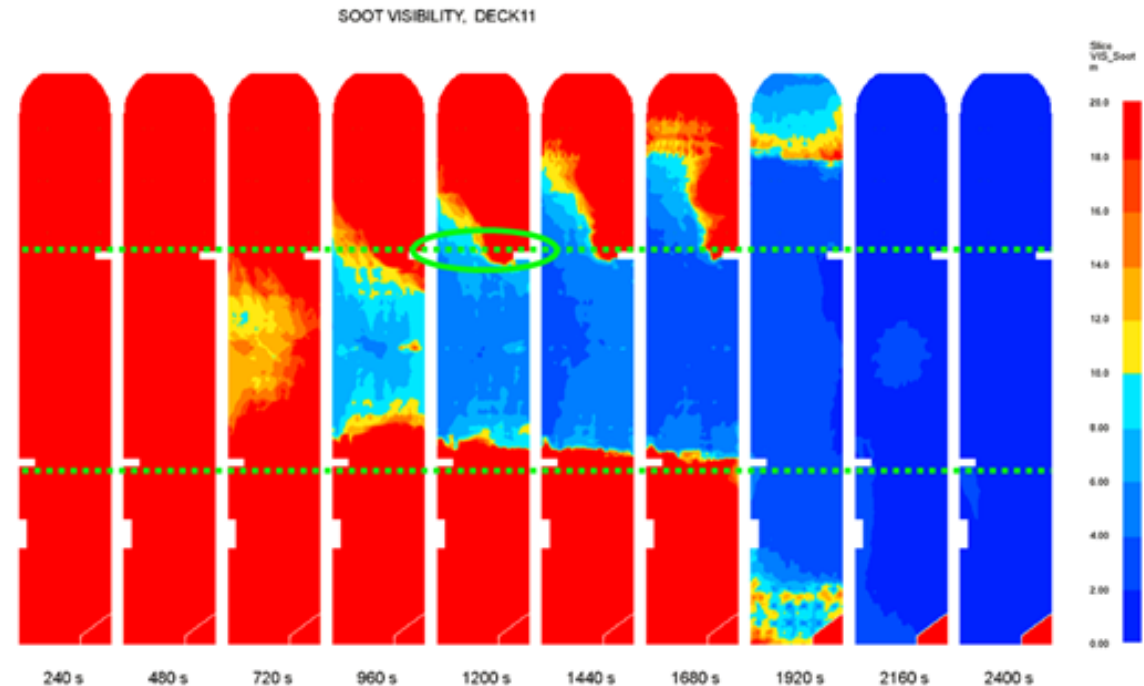
## Evacuation analysis

ASET = Available Safe Egress Time:

- Time to untenable conditions in a compartment:
  - Visibility: 1,8 m above floor level the visibility must be more than 10 m.
  - Temperature: max 60°C
  - Toxicity: 1,8 m above floor level:
    - CO > 1400 ppm
    - CO<sub>2</sub> > 5 %
    - O<sub>2</sub> < 15 %
    - HCL > 1000

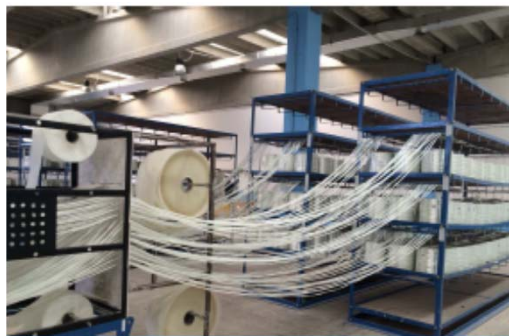
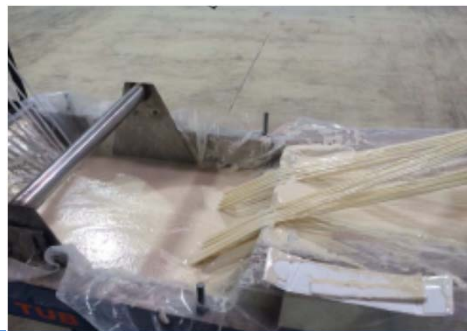
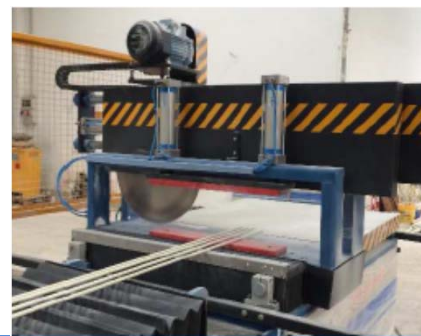
- -FRP structure design using the technology of Pultrusion
  - as a replacement of the sandwich composite panel
  - as a replacement of the sandwich composite panel and steel supporting structure
  - Combination of profiles and sandwich panel

**Expected improvements:** Improved flexibility in the design process, Production cost and lead time reduction, Joints development, Modular assembly of Composite components on board the ship
